ADVANCING ZERO HARM THROUGH TARP-DRIVEN GROUND CONTROL AT MASAKHANE D1 SHAFT

Driefontein Operation
Masakhane Shaft

**TARP Driven Geotechnical
Risk Management:**

Masakhane D1 Shaft Case Study

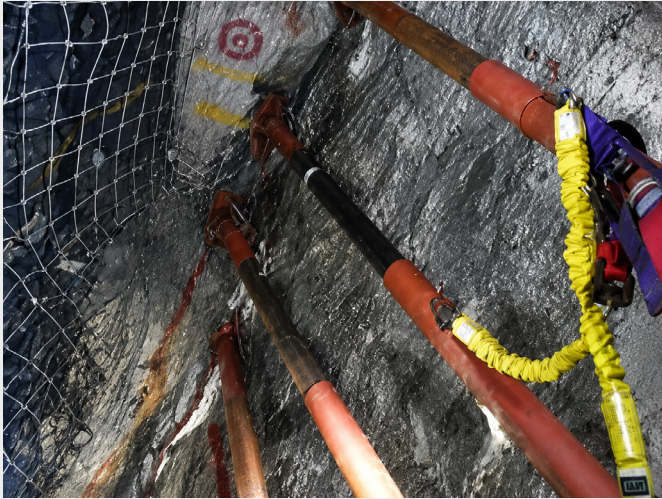
During the TARP Level 3 assessment at the VC38 25 10W panel, several critical conditions were identified. These included steep area exposure associated with the rolling reef, an overhanging face profile, partial off reef mining that adversely affected panel grade—and consequently the overall shaft grade, given the panel's ranking among the top ten producing panels—as well as excessive footwall waste. The elevated stoping width resulted in the over extension of installed omni props beyond their design specification, compromising support effectiveness.

Variable reef dip contributed to widespread fracturing and deterioration of the hangingwall, resulting in blast damaged conditions. These conditions manifested as significant hangingwall fractures and adverse mining features, including the formation of brows, which elevated fall of ground risk.

The support design limit of 2.2 m was exceeded, resulting in elevated stoping widths. This led to the over extension of primary support elements (PSEs) during installation and pre stressing, negatively affecting support installation and performance. Excessive stoping widths were also associated with a reduction in omni prop load capacity, leading to instances of buckling.

Mining across steeply rolling reef sections increased the extraction of footwall waste, resulting in higher ore dilution due to the reef dipping at approximately 45 degrees. This dilution adversely affected ore grade and had a direct economic impact on the operation.

Figure 5: Conditions prior to TARP visit
(Reef Rolling Steeply, Off Reef, High SW).

Following the implementation of TARP, in line with the seven prescribed steps—namely TARP training, planning classification, hazard identification, response team mobilisation, mitigation and response, treatment and control, and review—conditions at the VC38 25 10W panel showed marked improvement. Key interventions included the application of the approved support standard (MSI 1# 2025 01K – 10.6 m tight end heading, one dip strike gully), full exposure of the reef to improve panel grade and reduce dilution, and the enforcement of controlled stoping widths to ensure support units were installed strictly in accordance with specification.

In addition, steep area controls were reinforced through the installation of lifelines, and safety belts were issued to all crew members, with mandatory use enforced until steep area conditions were adequately stabilised.

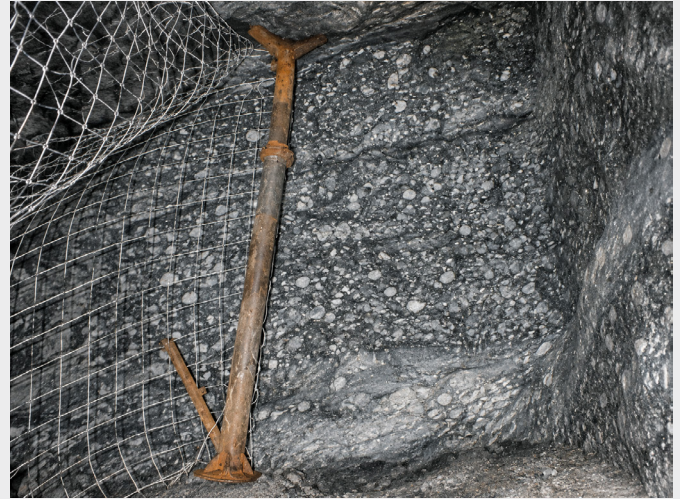
The panel is currently mined with the reef fully exposed, resulting in improved ore grade and a reduction in dilution associated with excessive footwall waste extraction.

The enforcement of controlled stoping widths has improved the performance and condition of installed support units. Support props are now installed in accordance with design

Figure 6: Post TARP -
Reef fully exposed and face not overhanging.

specifications, with no over extension, thereby enhancing overall hangingwall stability within the panel.

Steep area controls have been fully implemented, including the installation of a lifeline. All crew members have been issued safety belts, with mandatory use enforced until steep area conditions are adequately improved and stabilised.
