# Khutala Colliery

## Back-bye Management Strategy

5 June 2025

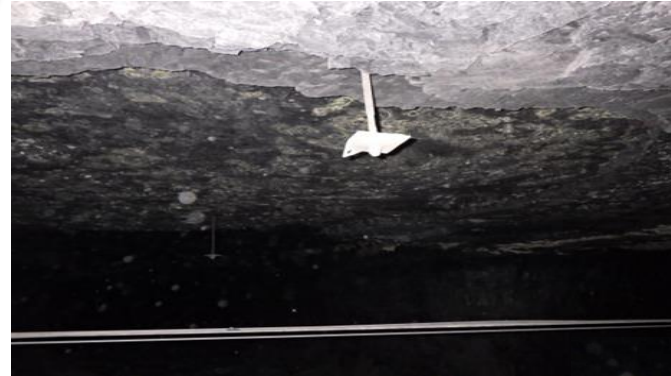
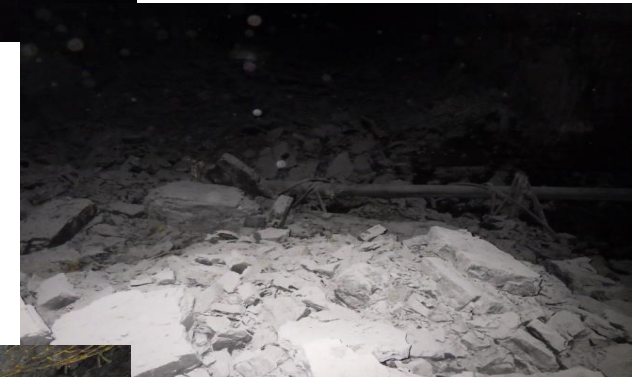
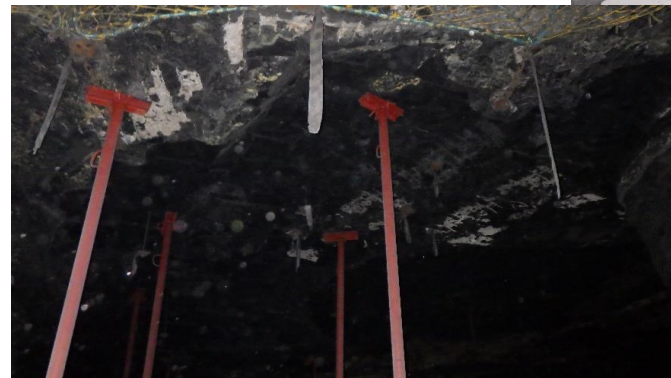
Most areas has been previously supported with 2 × 1.5m × 16mm long mechanical anchor roof bolts at a row spacing +/-2m.

Delaminated loose roof slabs have been identified within these areas thus; highlighting the risk of further roof slabbing.

Roof slabbing occurs between and around the roof bolts, resulting in ineffective loose/un-tensioned hanging roof bolts.

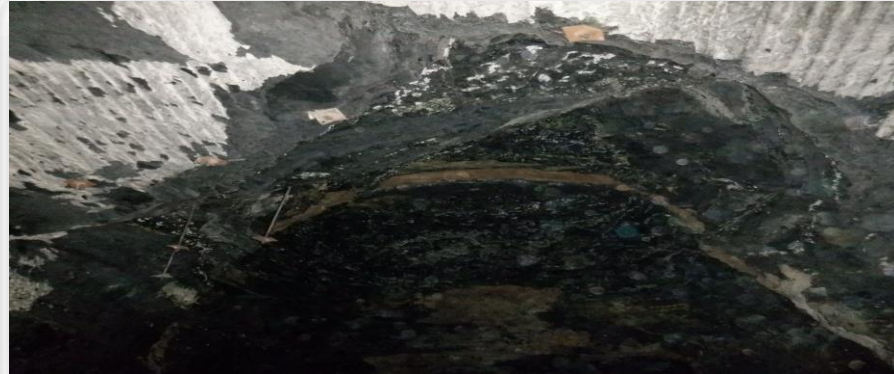
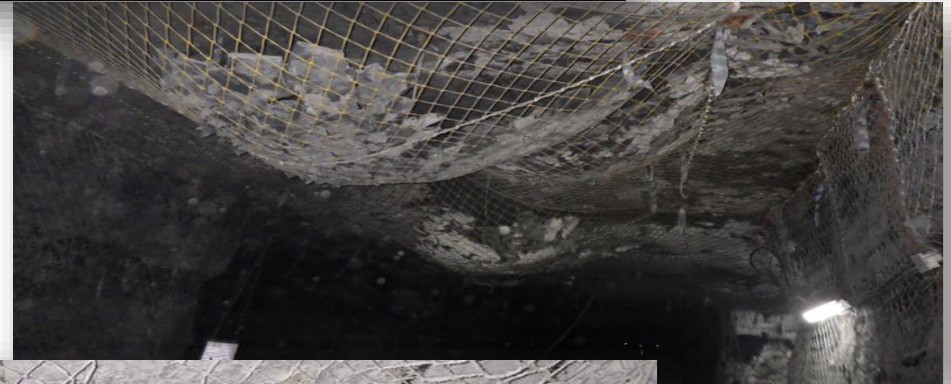
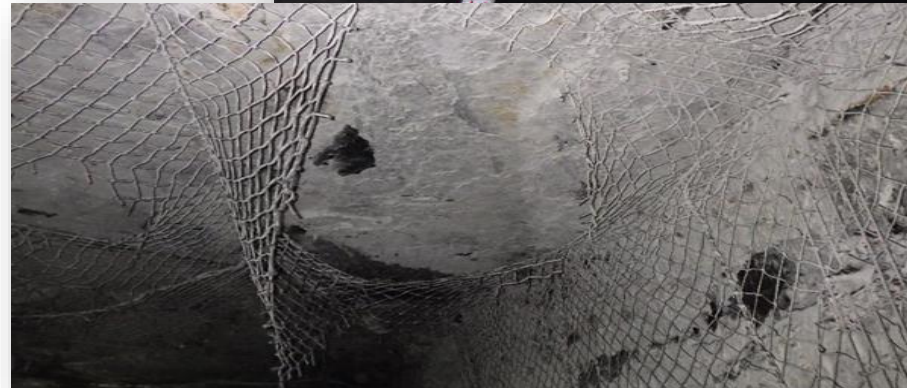
Major geological structures (Faults and Dykes), not previously fully supported.

Roof debris accumulation in the roof nets, which requires bleeding.

Torn roof nets which require replacement

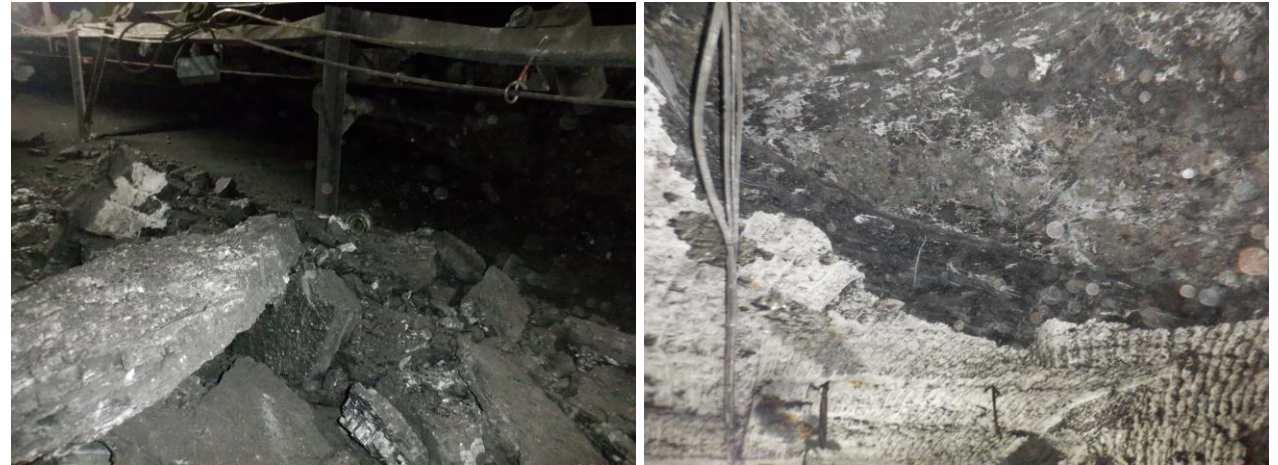
## 2 Seam Spine Belt (Sp.107-108)

Immediate roof slabbing consisting of a weak laminated coal stratum with an estimated thickness of 0.3 m, dislodged from an inadequately supported area resulting in “skin” failure of rock under its weight.

The area had been previously supported with 2 x 1.5m long x 16mm diameter mechanical anchor roof bolts per row, rows spaced at  $\approx 3.0$  m, hence the failure occurred between the roof bolts.

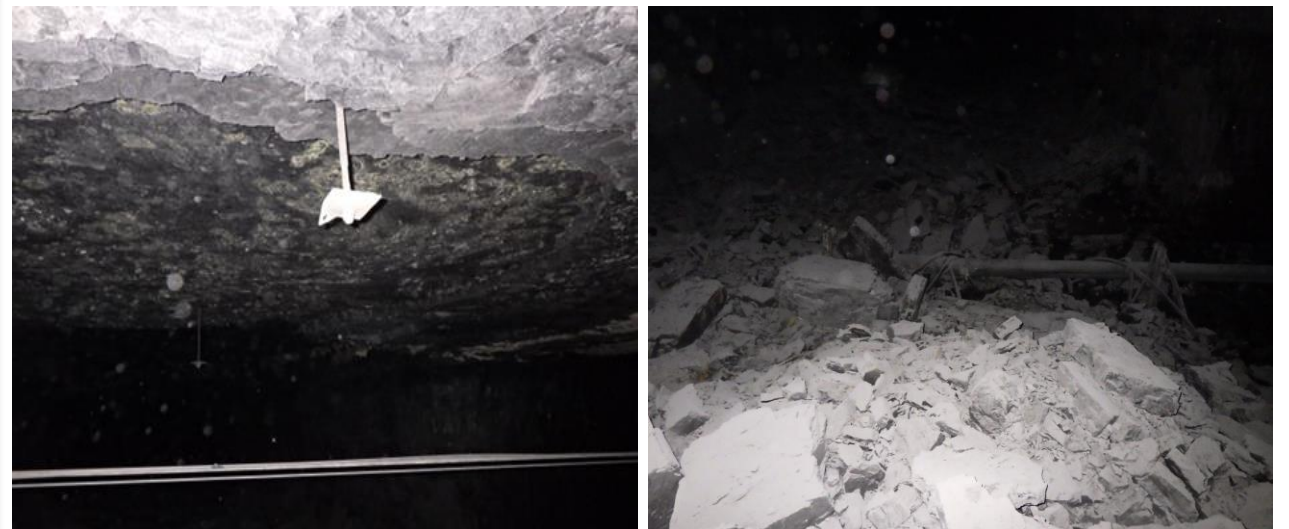
## 4 Seam Service Road (Backbye areas)

Immediate roof slabbing consisting of a weak laminated coal stratum with an estimated thickness of 0.2m, dislodged from an inadequately supported area, resulting in “skin” failure of the coal layer under its weight.

The roadway has been previously supported with 2 x 1.5m long x 16mm diameter mechanical anchor roof bolts per row, rows spaced at  $\approx 2.0$  m

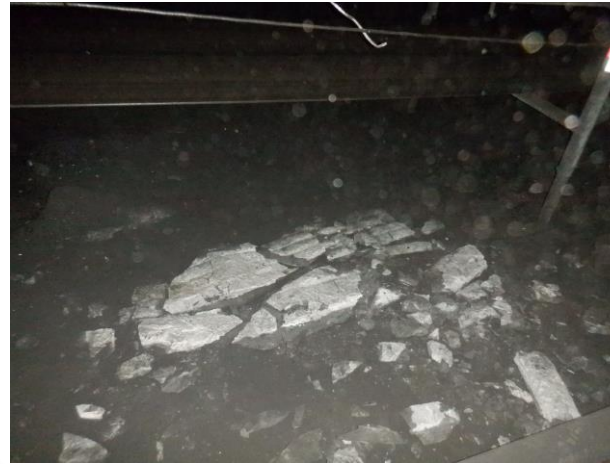
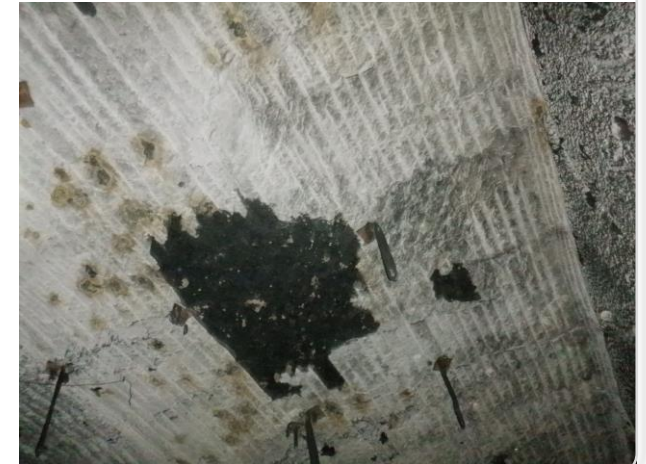
## 242 Belt Road

Roof slabbing of the laminated sandstone roof took place along 242 Belt Road between leg structures 85 and 86. A roof slab of approximately **1.5m (length) × 1.5m (width) × 0.03m (thickness)**, fell onto the belt structure. This resulted in a pull key wire being damaged by the failure.

The cause of the roof slabbing is due to the time dependent deterioration.

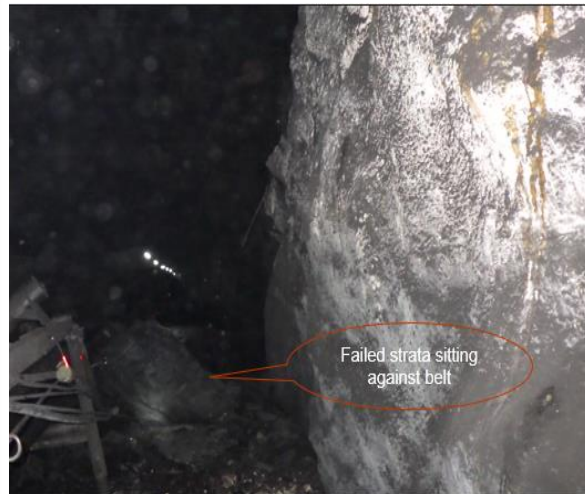
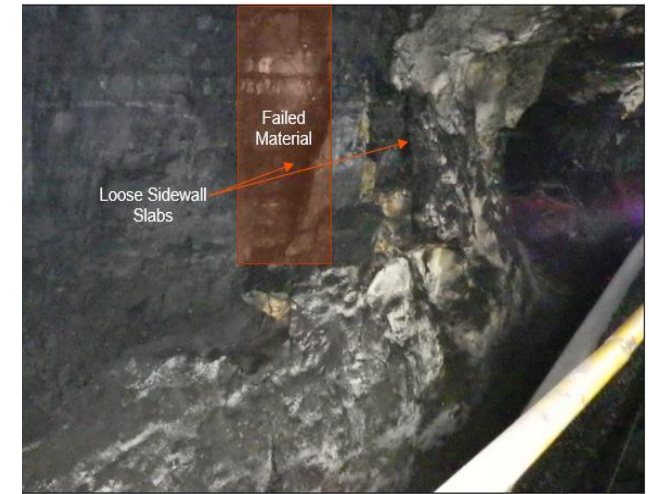
## 4E2 Belt (Sp.8-9)

Pillar sidewall scaling consisting of a coal block with an estimated thickness of **0.3m**, length of **2.0m**, and width of **1.0m**. No areal support (sidewall netting/welded mesh support) was installed at the time of failure

Heavy rainfalls also contributed to the added weight of the overlying strata (increasing vertical load) and thus causing the pillars to scale as a response to the additional load.

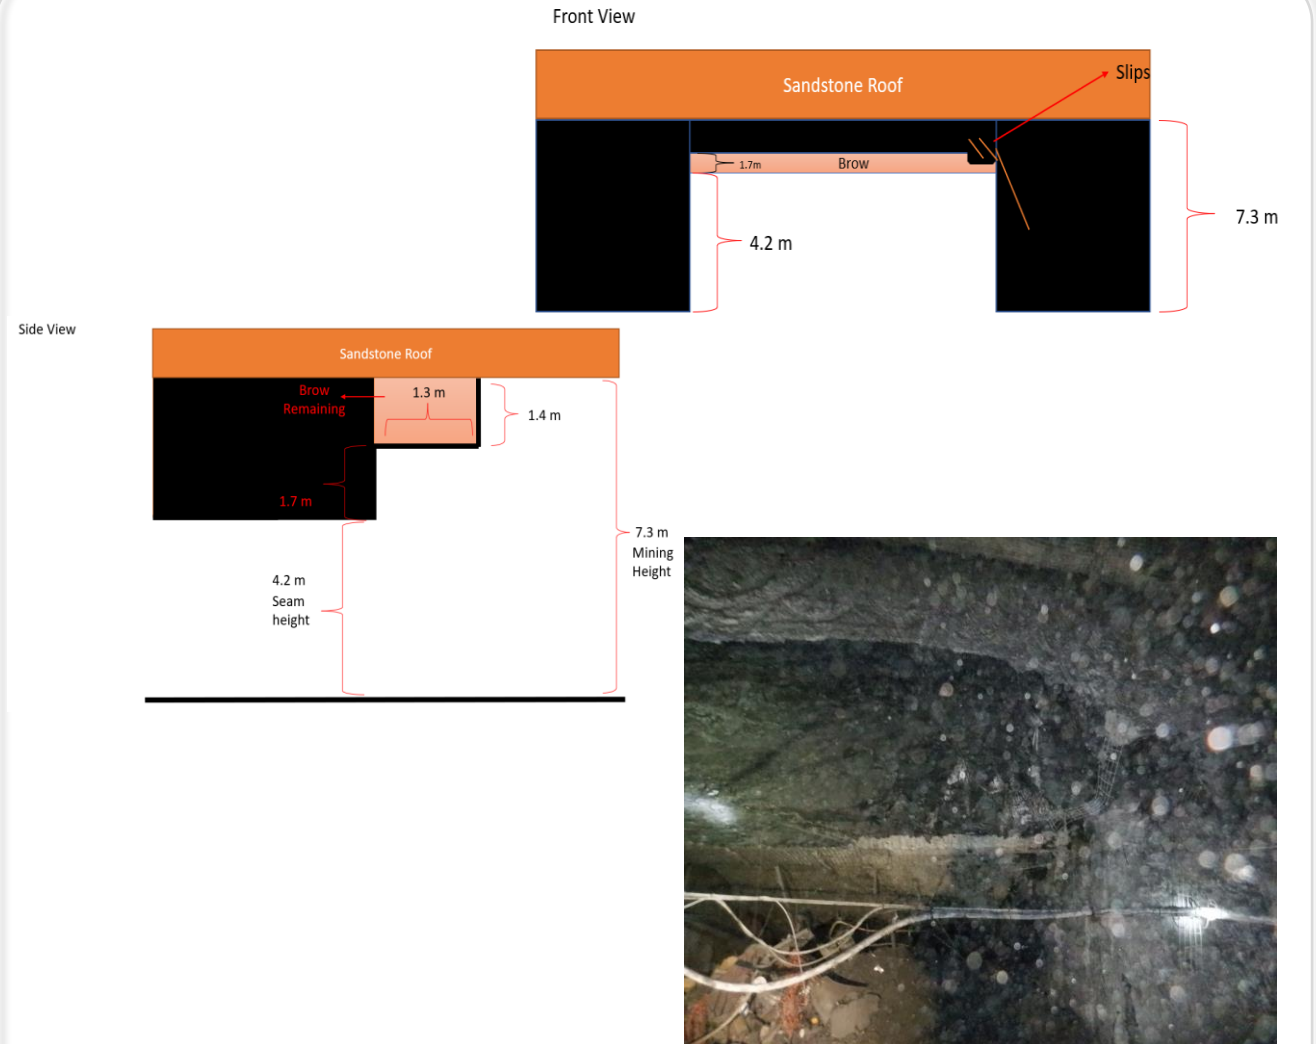
## 2E3 Traveling Road

Brow failure with estimated dimensions of **7.0m** wide x **1.3m** length x **1.7m** thick = **15.47m<sup>3</sup>** dislodged from within the main brow with a thickness of **≈3.1m** and fell into 2E3 traveling road

The mining dimensions, bord width and mining height were measured as **7.0 m** and **4.2m** (under the brow) – **7.3 m** (to the sandstone roof) respectively.

The above mining parameters are a consequence of total seam mining to accommodate the construction of air-crossings at the time.
