# MANAGING LOADED MESH

5 June 2025

# INCIDENT – TRIGGERED REVIEW ON BLEEDING

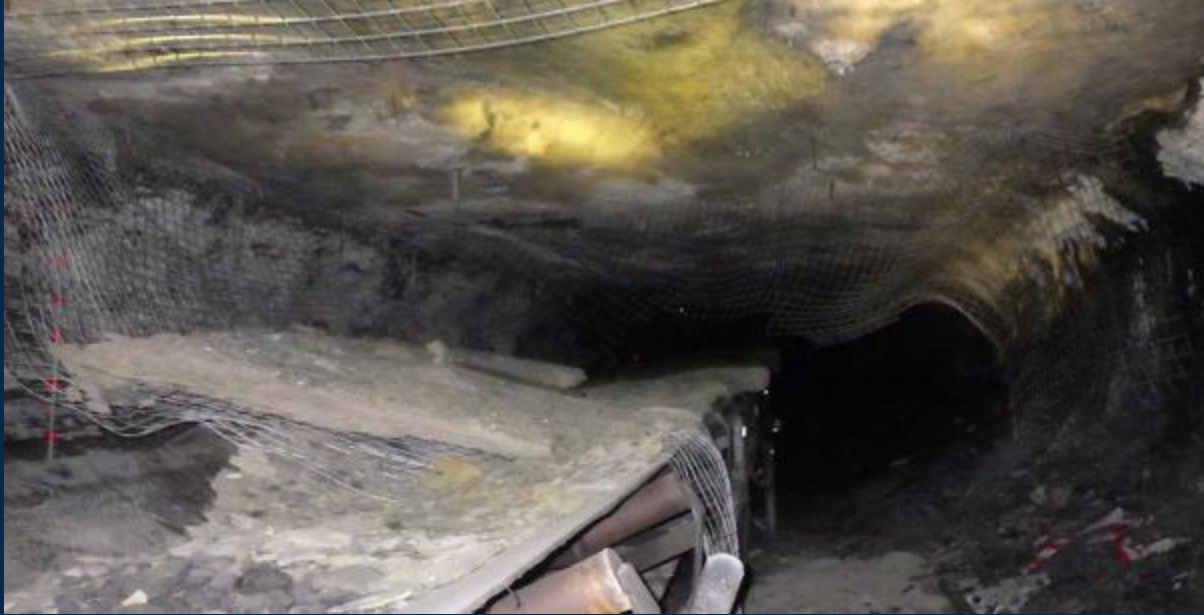
- 2 x persons where stationed on belt structure when cutting the mesh. ( LWDC) – High severity incident
- Size of loose material on top of mesh underestimated.
- Wrong positioning whilst cutting mesh.
- Cutting tool did not enable cutting from a safe distance / position.

- Need a special cutting tool to allow cutting from a safe distance (2.5m away from fall path)
- Need a proper method statement to guide team on what procedure to follow for different scenarios. – Derived from a risk assessment
- Higher level supervision – to indicate cutting strategy and the safe position when cutting from different position.
- Discipline from team to adhere to the procedure as the procedure will not always be the easiest and fastest way.

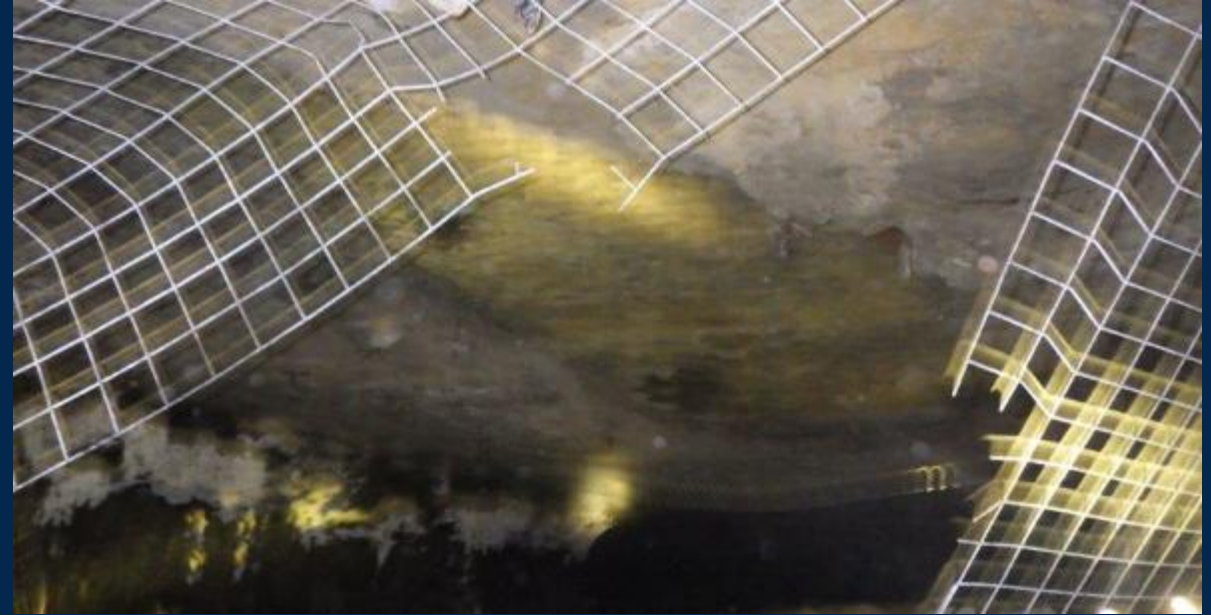
- Yellow stains on roof of fall cavity– oxidation indicates existing delamination with air and water on bedding plane.
- Notice how wires were cut around the bolt plates rather than along the length of the sheet.

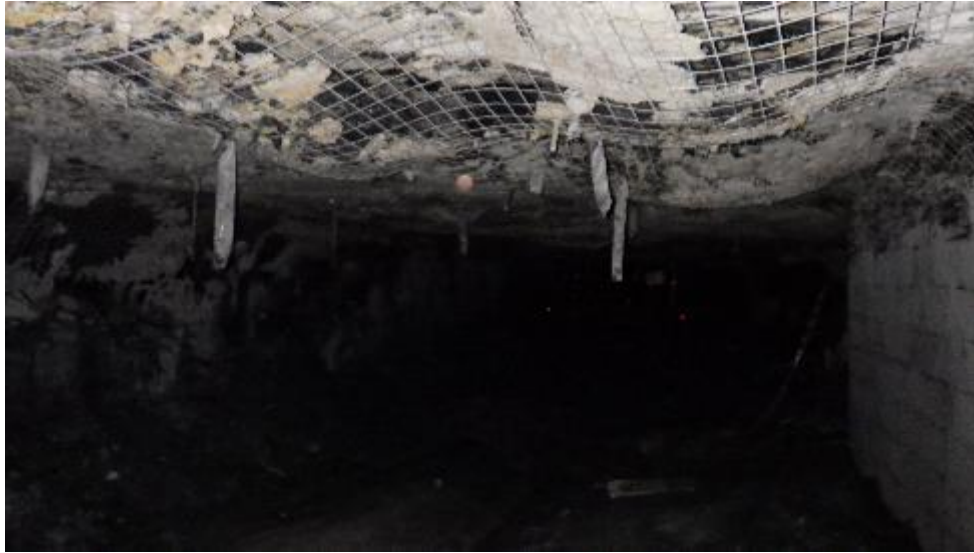
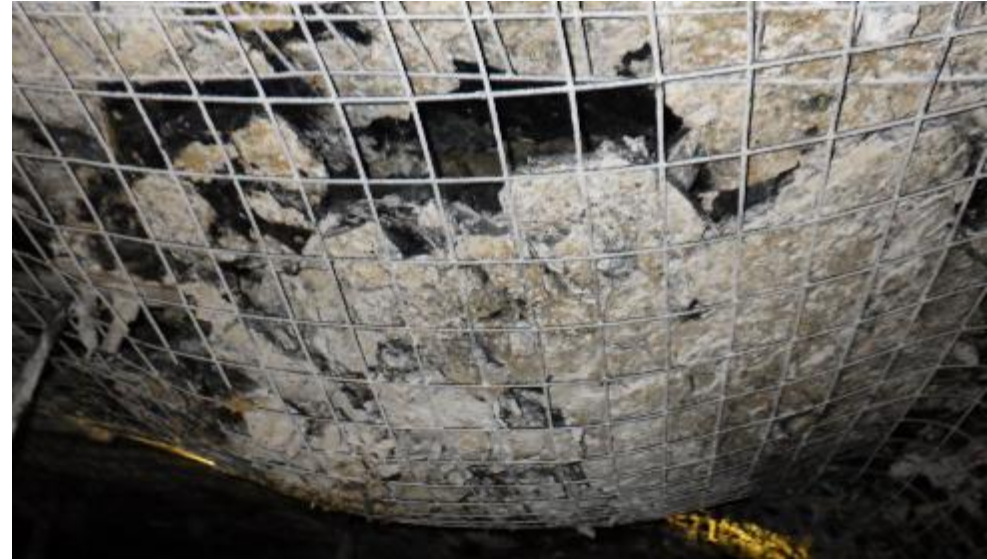
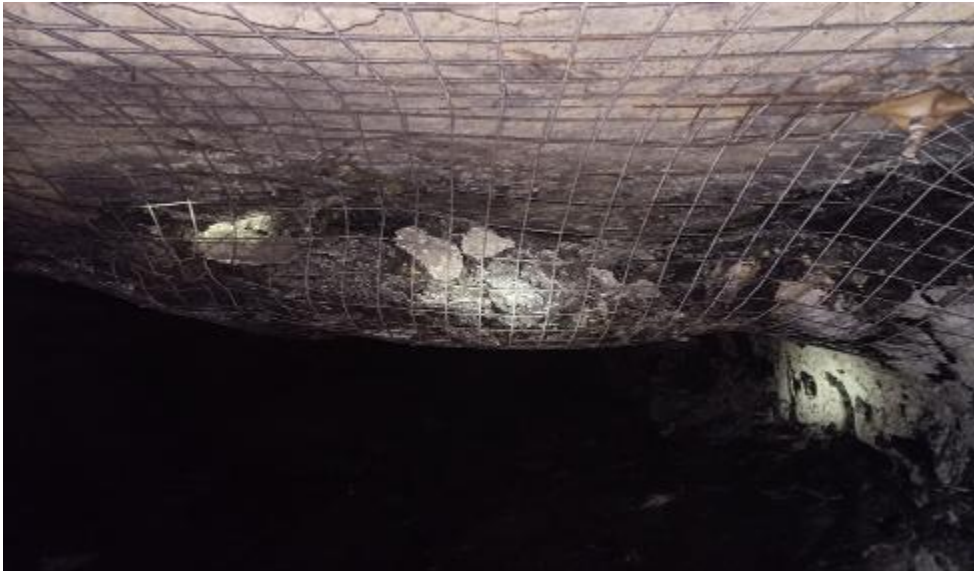
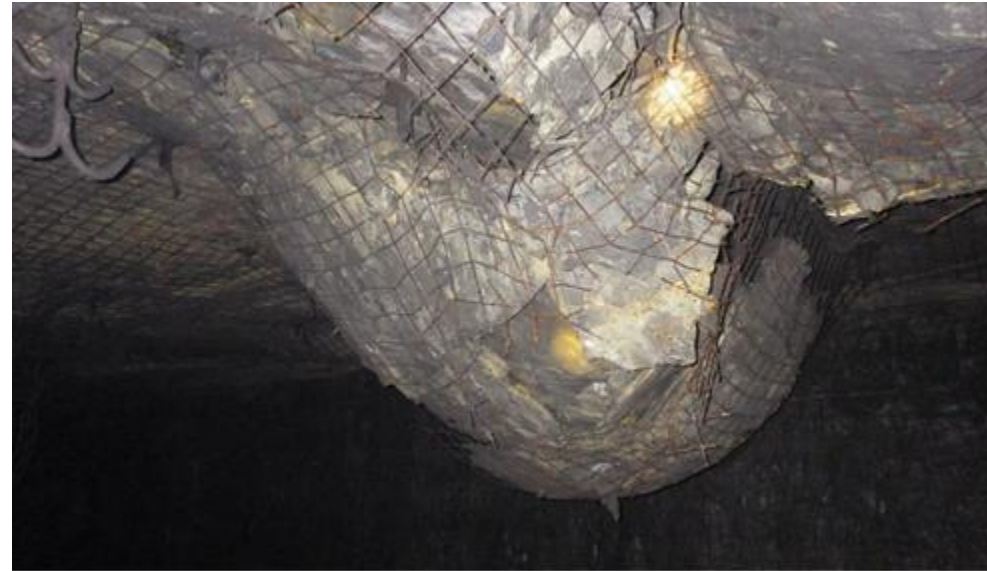
# STAGES OF MESH LOADING

## • NONE / SLIGHTLY LOADED MESH

- Accept residual risk.
- No immediate action.
- Monitoring strategy.

## • LOADED MESH

- Strap.
- Double nut new sheet of mesh over existing loaded sheet.

## • OVERLOADED MESH

- Focused bleeding – higher level supervision required.
- Mechanical remote removal.
- Strap if localized area with safe access is available.
