# Kriel Colliery

## Intersection Failure Management

Lindokuhle Khumalo

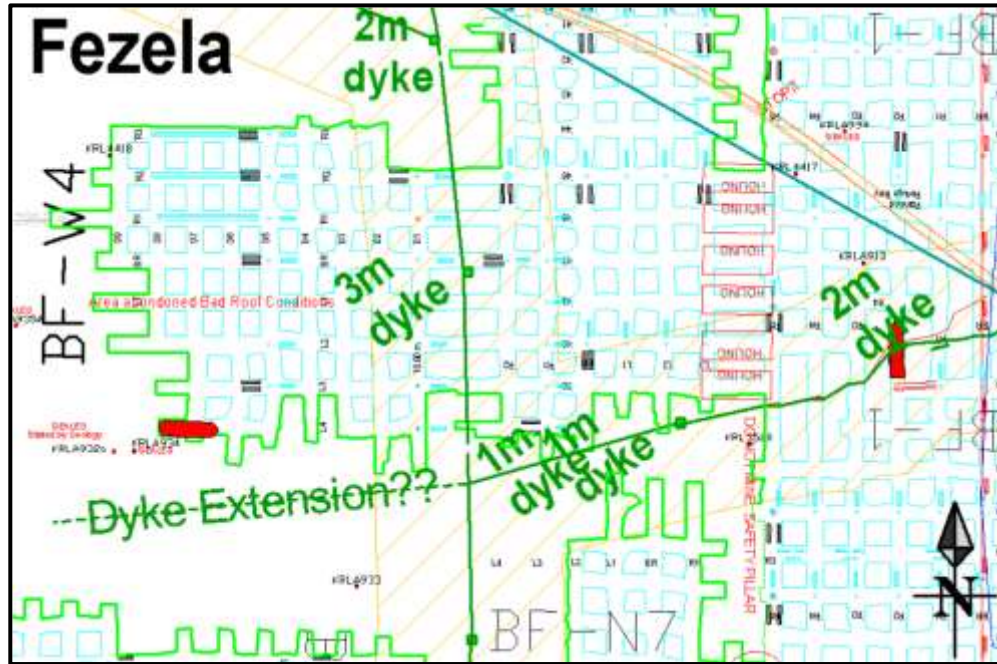
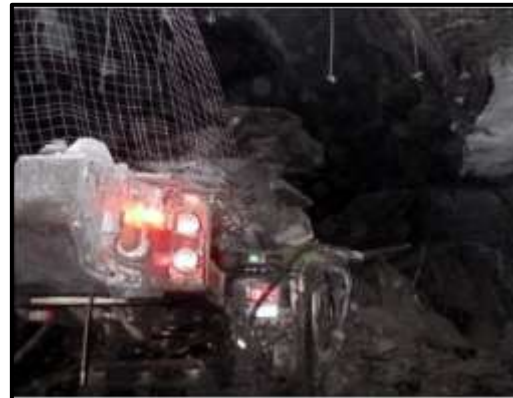
Fezela 02 August 2021 FOG

| Parameters | Frequency |
|---|---|
| Location | BF-W4, Road L4 split 7 |
| Depth | ±53m DTF |
| Bord width | 7.2m |
| Stand-up time | During development. |
| Roof Lithology | 2.79m of interlaminated siltstone, sandstone and shale i.e laminated roof |
| Geotechnical Anomalies | <ul style="list-style-type: none"> <li>Poor ground conditions experienced in neighboring roadways as well as roadway leading up to FoG.</li> <li>Proximity to a dyke on the southern side.</li> <li>Dolerite Sill on the floor (devolatilised ground).</li> </ul> |
| Support | <ul style="list-style-type: none"> <li>The systematic support pattern reportedly consisted of 5 x 1.8 m long, full column resin (FCR) bolts</li> <li>Bolts installed concurrent with welded mesh,</li> <li>support rows spaced ±1 m apart, i.e. 1.33 m² per bolt or 0.77 bolts per m² of roof exposed.</li> </ul> |

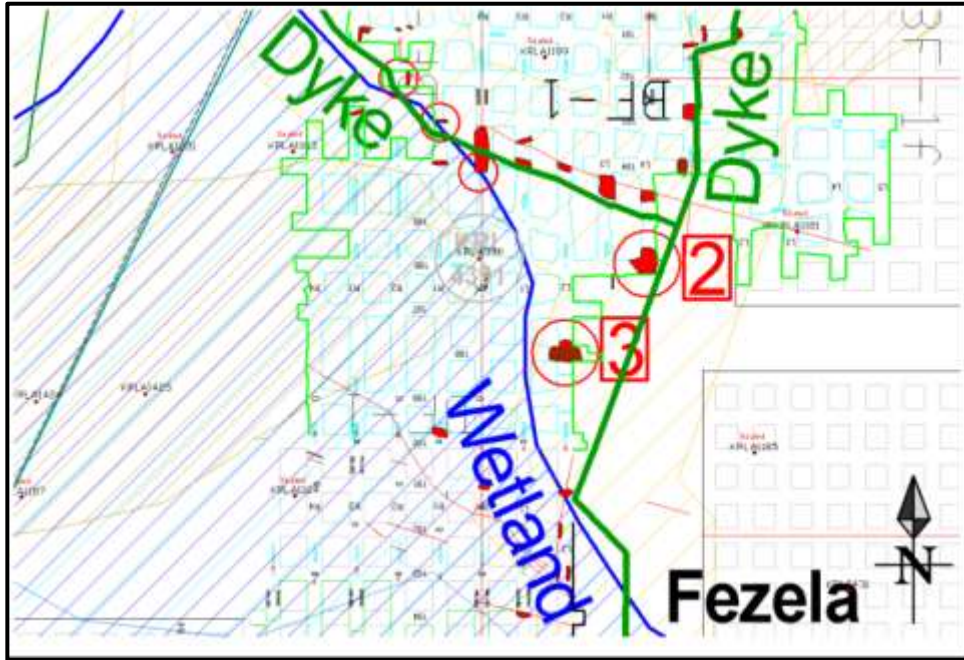
Fezela 17 January 2024 FOG

| Parameters | Frequency |
|---|---|
| Location | Panel BF-1 , BR split 186 |
| Depth | ±46m DTF |
| Bord width | 6.8m - 7.2m |
| Stand-up time | ≤ 12 hours after mining |
| Roof Lithology | <ul style="list-style-type: none"> <li>Burnt coal zone, immediately adjacent to a dyke.</li> <li>Roof strata comprise of interlaminated and interbedded siltstone and carbonaceous shale (2.96m thick).</li> </ul> |
| Geotechnical Anomalies | <ul style="list-style-type: none"> <li>NNE-SSE dyke on contact and NW-SE dyke ± 13 m to the north.</li> <li>Dolerite sill within 10m of #S4 coal seam.</li> <li>Just outside surface wetland demarcation (i.e. within 100m).</li> </ul> |
| Support | <ul style="list-style-type: none"> <li>6 x 1.8 m long, full column resin (FCR) bolts, installed in consecutive rows, spaced ±1 m apart,</li> <li>Support installed concurrently with welded mesh i.e. 1.1 m² per bolt or 0.92 bolts per m² of roof exposed.</li> </ul> |

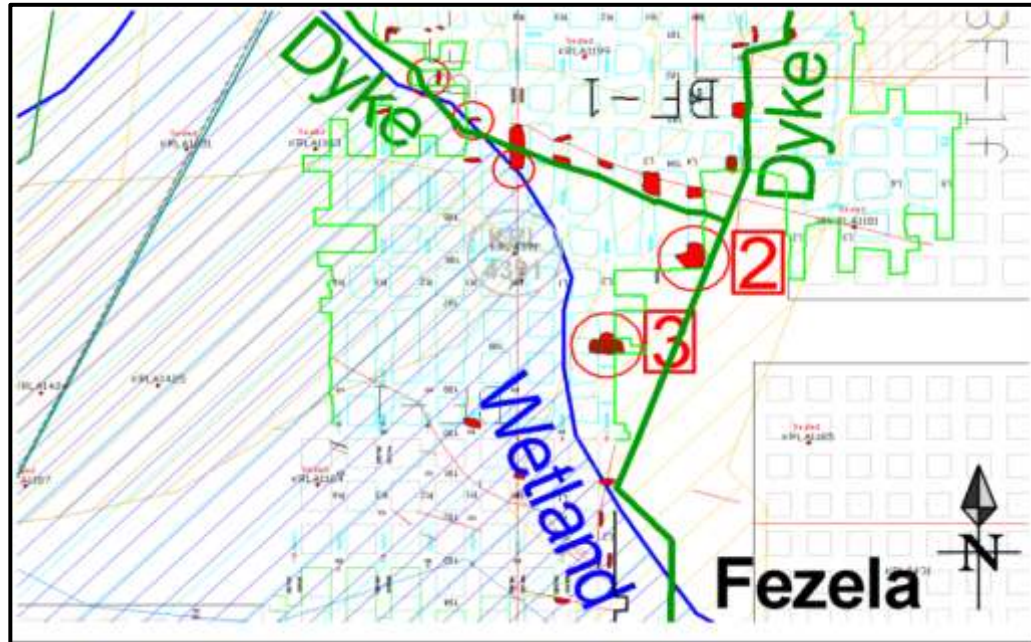
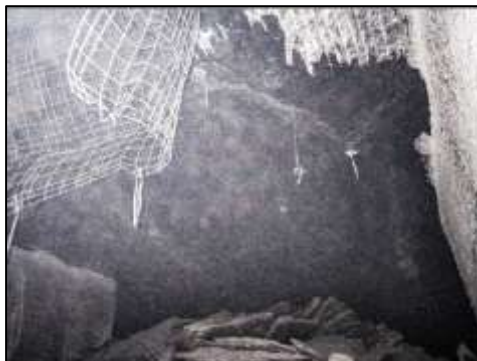
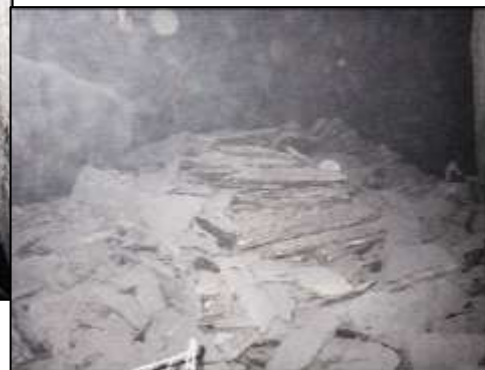
Fezela 06 June 2024 FOG

| Parameters | Frequency |
|---|---|
| Location | Panel BF-1, Road L2 split 188 |
| Depth | ±46m DTF |
| Bord width | 6.8m - 7.2m |
| Stand-up time | ± 2 months |
| Roof Lithology | <ul style="list-style-type: none"> <li>Roof strata comprise of interlaminated and interbedded siltstone and carbonaceous shale.</li> </ul> |
| Geotechnical Anomalies | <ul style="list-style-type: none"> <li>Adjacent to a dyke on the eastern side.</li> <li>Slips encountered across split 188.</li> <li>Dolerite sill in the roof.</li> <li>Surface wetland proximity.</li> </ul> |
| Support | <ul style="list-style-type: none"> <li>The systematic support pattern consisted of 5 x 1.8 m long, full column resin (FCR) bolts, installed in rows spaced ±2 m apart, i.e. 2.88 m² per bolt or 0.35 bolts per m² of roof exposed.</li> <li>Welded mesh was installed concurrently with the systematic support, reportedly for the coverage of the slip.</li> </ul> |

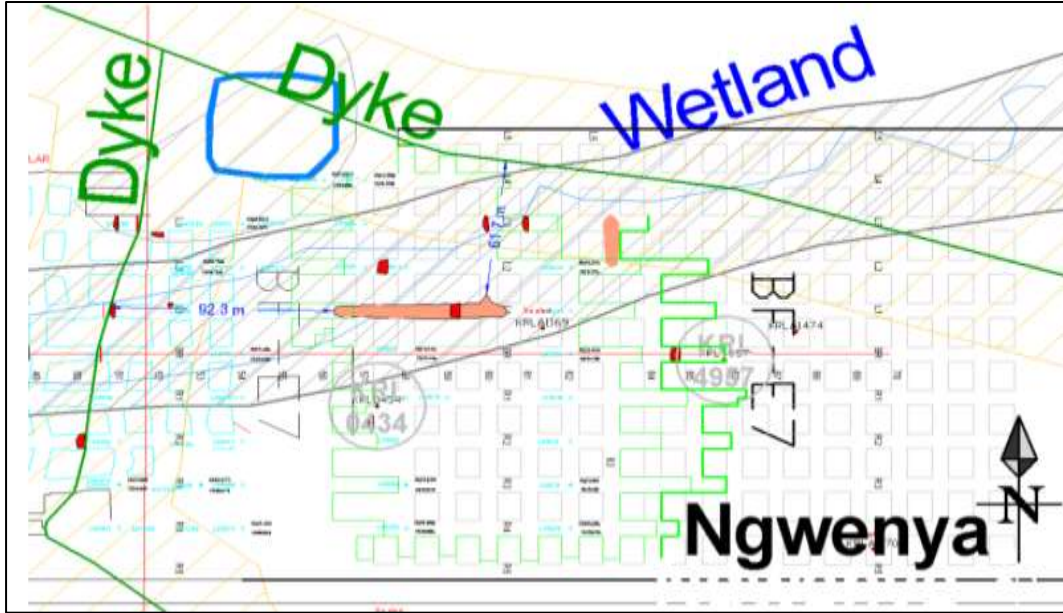
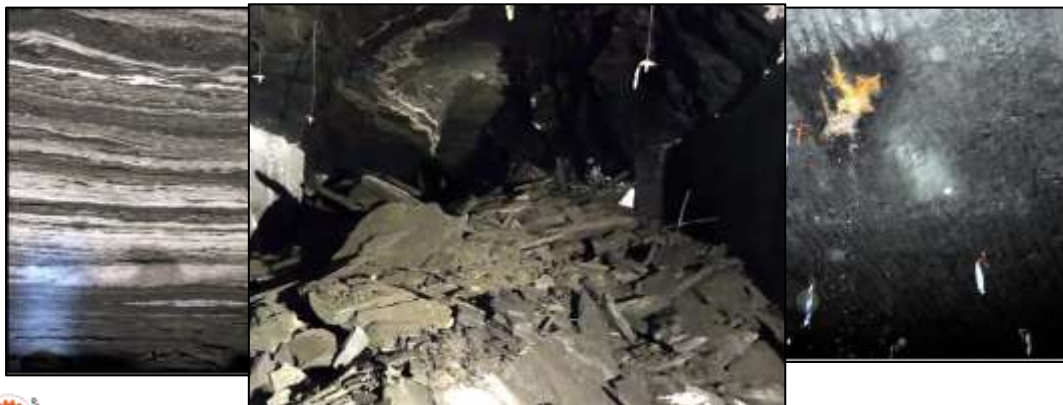
Ngwenya 06 July 2024 FOG

| Parameters | Frequency |
|---|---|
| Location | Panel BF-E7, Road L1 split 58 |
| Depth | ±42m DTF |
| Bord width | 7.2m |
| Stand-up time | ±2 – 3 weeks after mining |
| Roof Lithology | 2.95 m thick, carbonaceous fines (siltstone) layers of varying thicknesses within the immediate roof. |
| Geotechnical Anomalies | <ul style="list-style-type: none"> <li>Two dykes in close proximity, WNW-ESE dyke ±62 m to the north and NNE-SSE dyke ±92 m to the west.</li> <li>Surface stream (Wetland) proximity with significant amount of water in roof.</li> <li>Significant water pressure and seepage in the roof.</li> <li>Possible washed out and/or weaker resin bond.</li> </ul> |
| Support | <ul style="list-style-type: none"> <li>Systematic support pattern of 4 x 1.8 m long, full column resin (FCR) bolts, spaced 2 m apart, i.e. 3.6 m<sup>2</sup> per bolt or 0.28 bolts per m<sup>2</sup> of roof exposed.</li> </ul> |

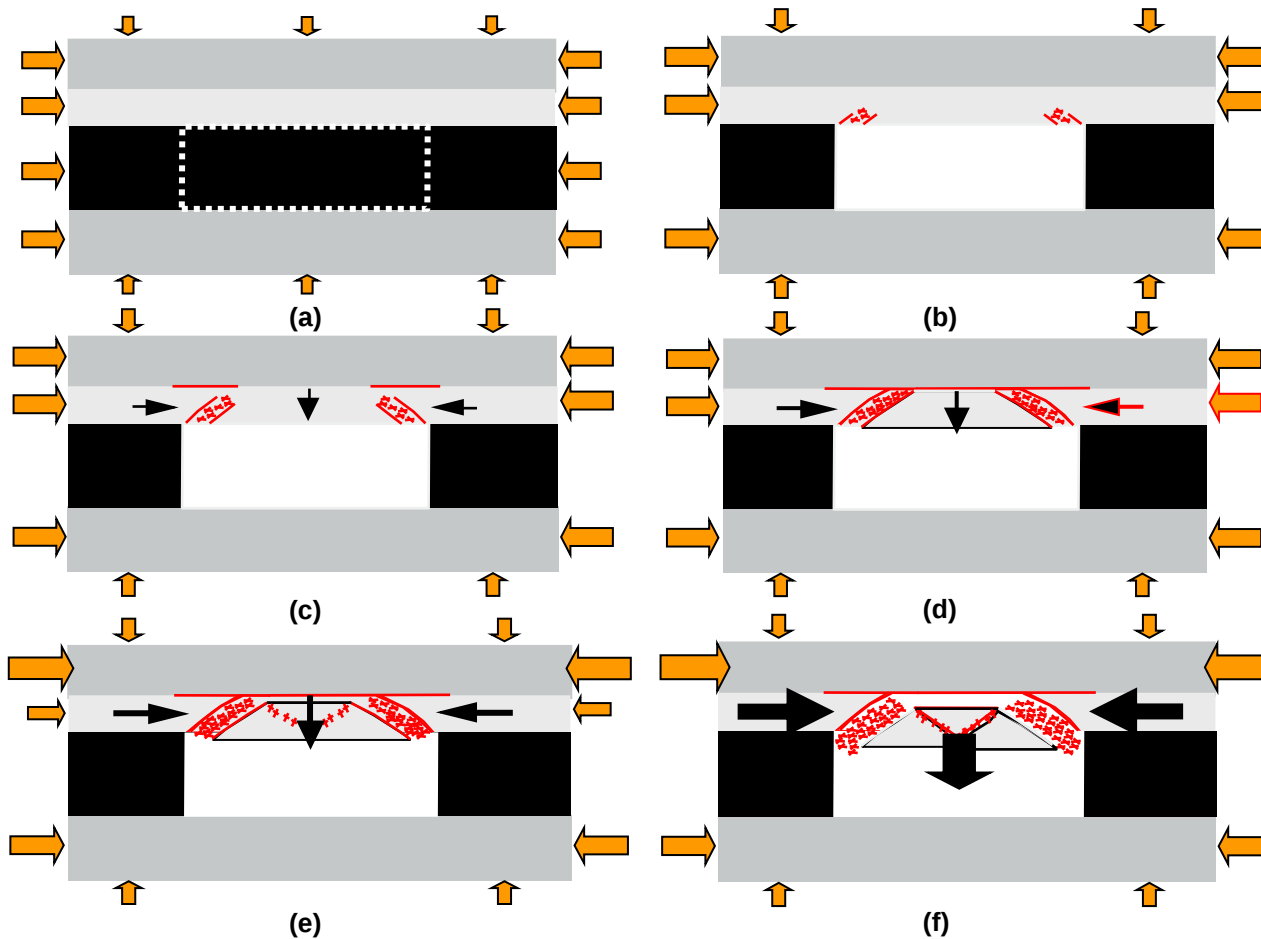
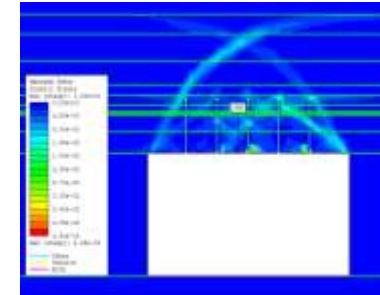
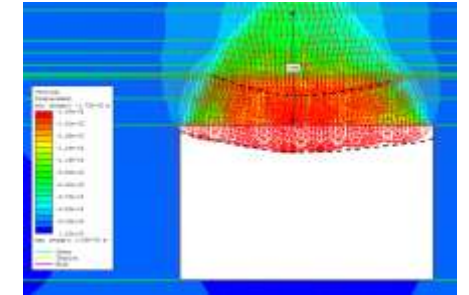
## Failure Mechanism

- Failure initiates from the corners ( max. shear at corners).
- Failure could potentially over-run the installed support ( bolts on the edges to far from pillar sidewall).
- Simplified RS2 simulations provided reasonable estimates of the possible failure mechanism.
