**MINING INDUSTRY  
OCCUPATIONAL  
SAFETY & HEALTH**

**MINERALS COUNCIL  
SOUTH AFRICA**

# NETS WITH BOLTS IMPALA CASE STUDY

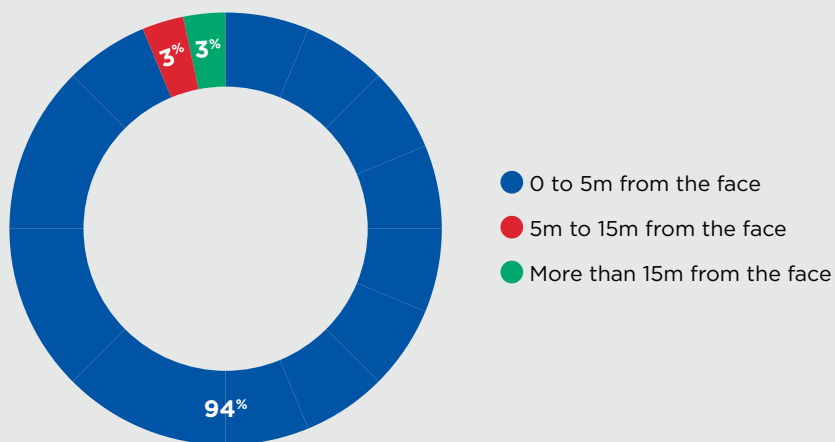
**FIGURE 1:**  
Location of falls of ground

The falls of ground incidents between July 2023 and January 2025 in Figure 1 indicate that 94% of falls of ground occurred within 0 to 5 metres from face, this shows that the risk of falls of ground is extremely high in the immediate vicinity of the face. The falls of ground incidents occurring 5 to 15 meters from the face and more than 15 meters from face each have a percentage of 3%. The data shows that 94% of falls of ground are in the immediate vicinity of the face; there is still a 6% chance of other falls of ground in the wider areas of the mine. Therefore, effective risk management strategies are crucial in reducing the incidence of falls of ground, which pose significant safety hazards to mine workers.

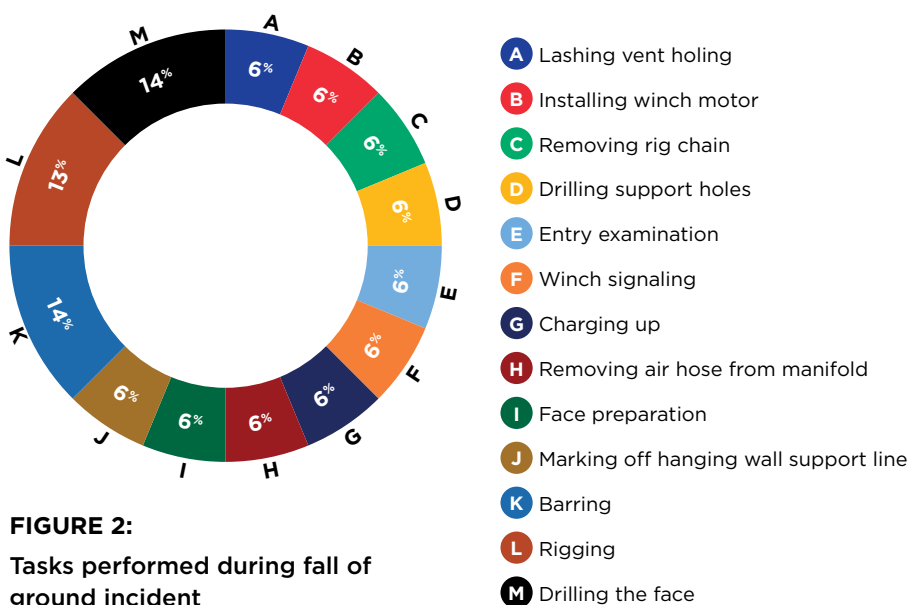
**FIGURE 2:**  
Tasks performed during fall of ground incident

Figure 2 indicates the tasks being performed during fall of ground (FoG) incidents from July 2023 to January 2025. Barring had the highest percentage of FoG incidents, and a significant number of incidents occurred during drilling and rigging. These tasks involve direct interaction with the rock, highlighting the need for safety measures and monitoring.

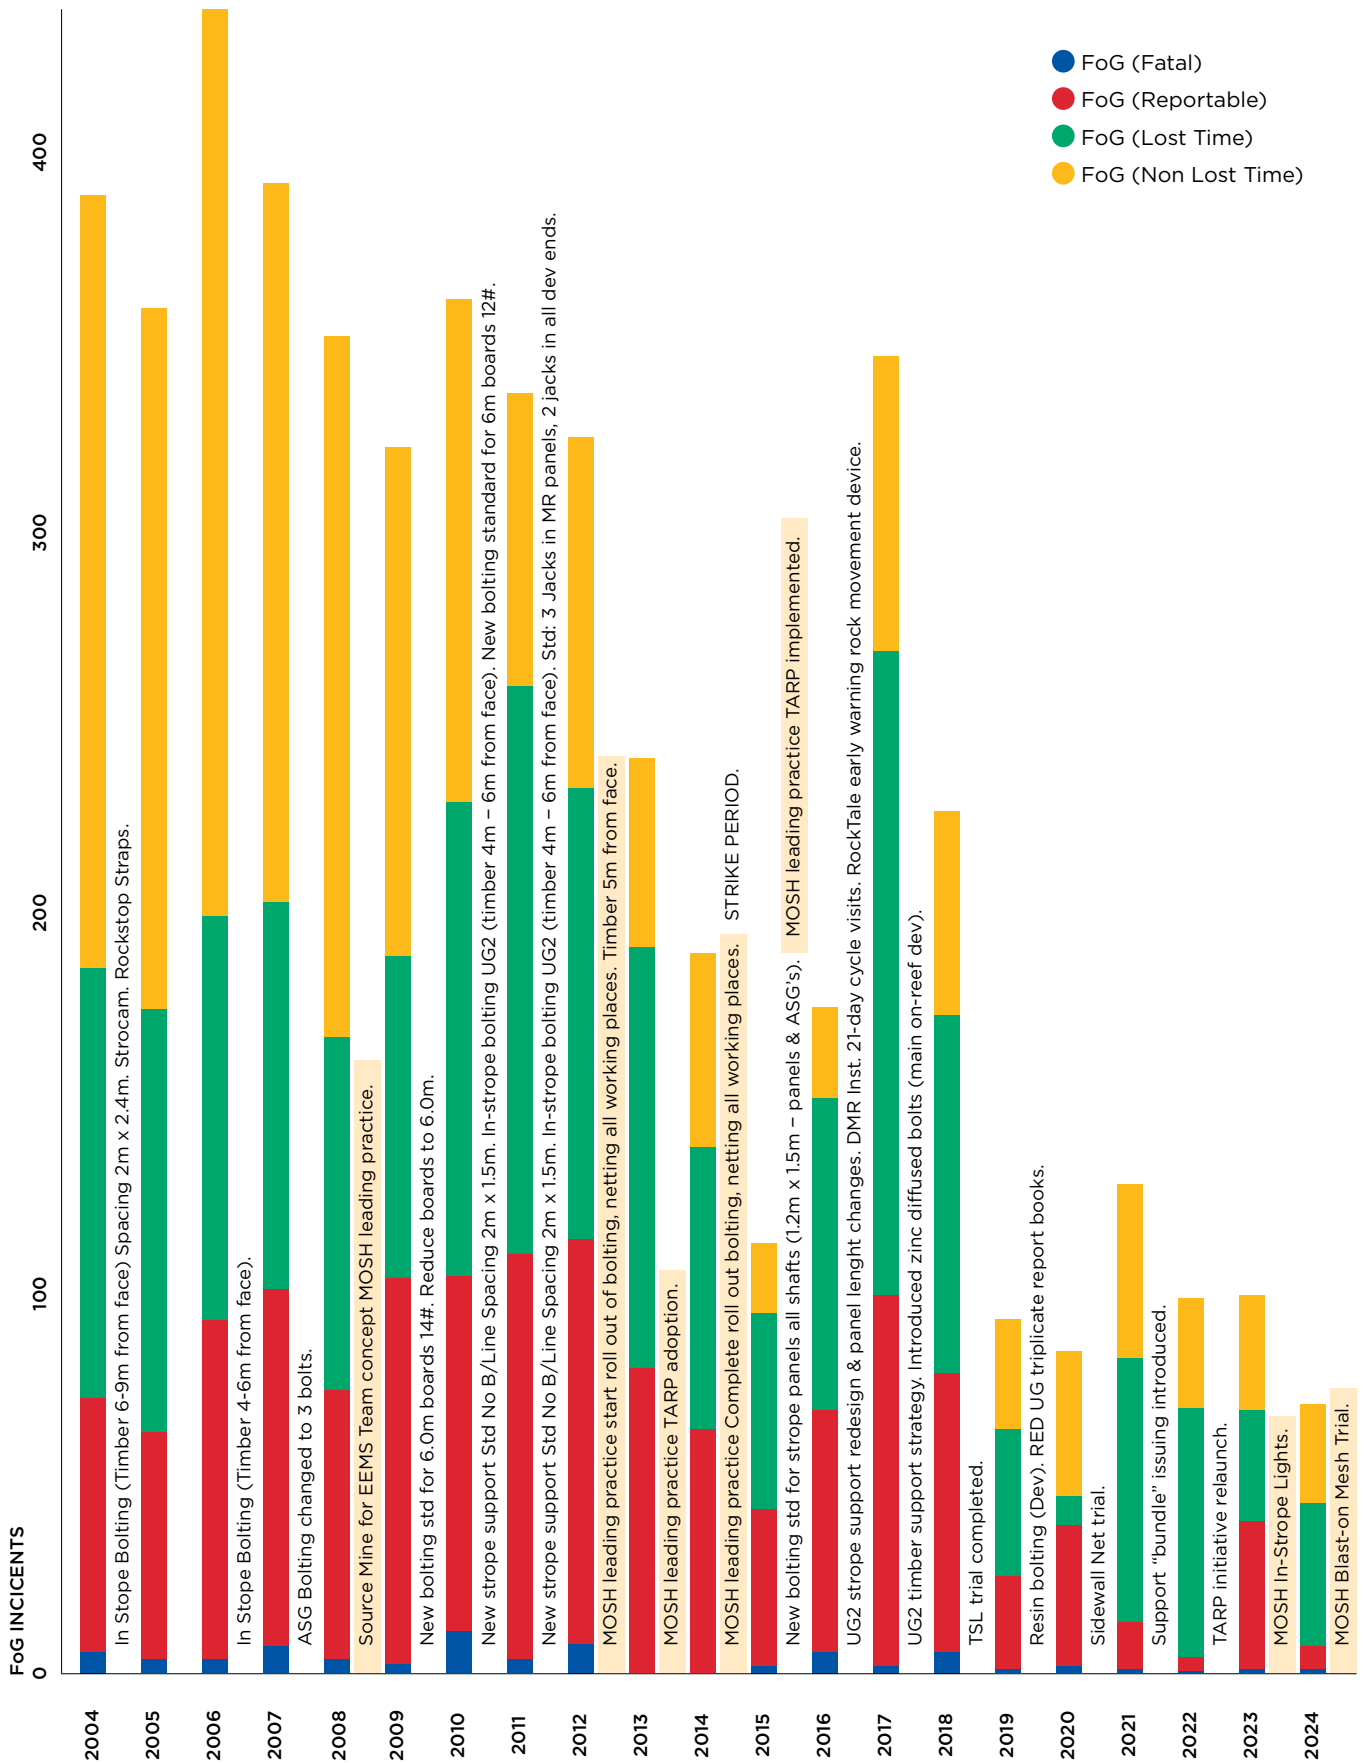
**FIGURE 3: Fall of ground incident data and safety initiatives between 2004 and 2024**

Data on Impala Platinum's fall of ground (FoG) incidents and safety initiatives from 2004 to 2024 are presented in Figure 3.

- High levels of FoG incidents occurred between 2004 and 2008, with peaks in 2005 and 2008, indicating significant safety challenges.
- Between 2009 and 2012, there is a gradual decrease in incidents, suggesting improvements in safety practices.
- Fluctuations in incidents between 2013 and 2018, with notable peaks in 2015 and 2017, suggesting periods of increased risk or reporting.
- Between 2019 and 2024, there is a notable downward trend, indicating effective safety strategies and reduced incident rates.

- Early initiatives from 2004 to 2010 focused on improving support standards and introducing new bolting and netting practices.
- Impala adopted safety nets in 2012, and full scale roll out across the operations was achieved in 2014.
- Recent Initiatives from 2016 emphasise on UG2 support improvements, resin bolting, and sidewall support. The TARP (Trigger Action Response Plan) was also adopted to enhance proactive safety measures. Impala 16 Shaft started the permanent work face areal mesh trial in June 2024.

Overall, the graph demonstrates Impala's commitment to reducing fall of ground incidents through continuous improvement in safety practices and adoption of leading practices and innovative technologies. The downward trend in incidents over the years highlights the positive impact of these safety initiatives.

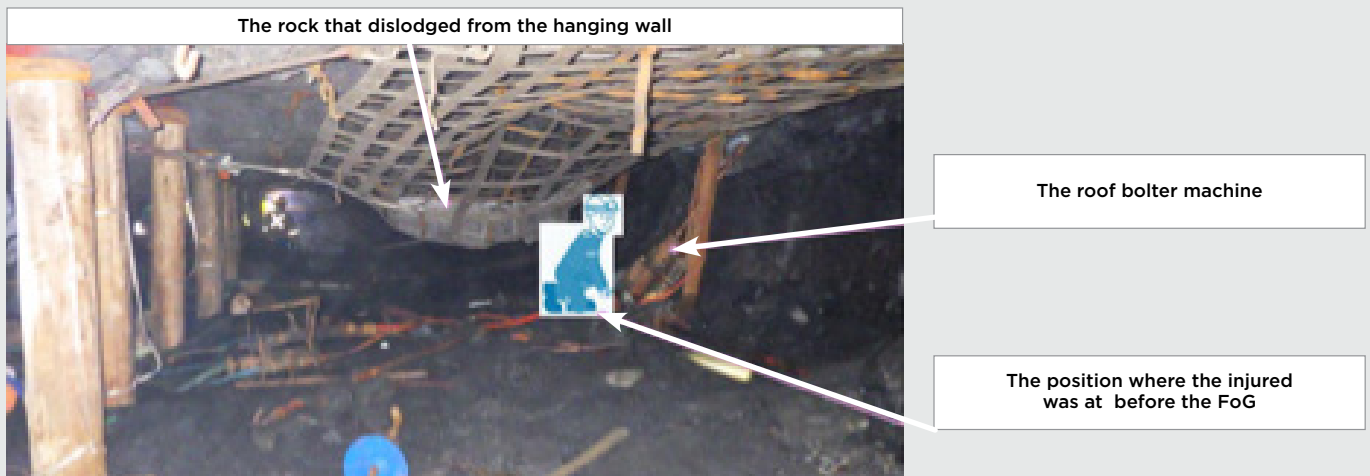
**FIGURE 4:** Image indicating the accident scene

On 24 June 2024 at about 10h00 in the morning, the scrapper winch Operator was busy changing the steel jumper on a roof bolter machine when a rock dislodged from the hanging wall of the 23C 20 13S panel and struck his helmet, whilst the rock was being arrested by the rockstop safety net. The operator sustained contusion to the head.

The incident highlights the critical importance of effective communication between shifts, thorough safety examinations before beginning work, strict compliance with safety protocols regarding drilling, and ensuring the proper installation of S-hooks to maintain the integrity and effectiveness of safety nets.

1. Whenever temporary support is not removed at the end shift, the day shift miner must communicate to night shift crew not to enter the face area.
2. At the start of next day shift, early entry examination must be conducted to declare the workplace safe. The temporary support will have to be reinstalled immediately after the workplace is declared safe.
3. No drilling must be allowed onto an area that was not examined and made safe.
4. S-hooks must be attached to safety net strands to minimise elongation or sagging of the safety net when it arrests the fall of ground.
