ADVANCING ZERO HARM THROUGH TARP-DRIVEN GROUND CONTROL AT MASAKHANE D1 SHAFT

Driefontein Operation
Masakhane Shaft

**TARP Driven Geotechnical
Risk Management:**

Masakhane D1 Shaft Case Study

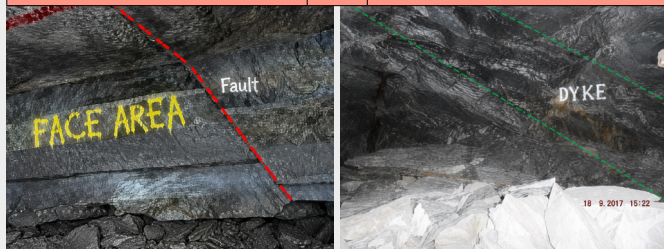
Figure 2: Geological Features.

Hazard	Level	Remedial action
Minor Fault, Dyke, Roll with no or little displacement (reef on other side exposed)	T 1	Make safe Install temporary support Support feature on both sides
New exposure on face. Flat dipping discontinuity (less than 35 degrees to normal strata / hanging wall)	T 2	Make safe Install temporary support Support discontinuity on both sides
Major Fault, Dyke, Roll which results in a change in stoping width. (reef not exposed on other side)	T 3	Barricade off the affected area. Log in miner's declaration book Notify the T3-team

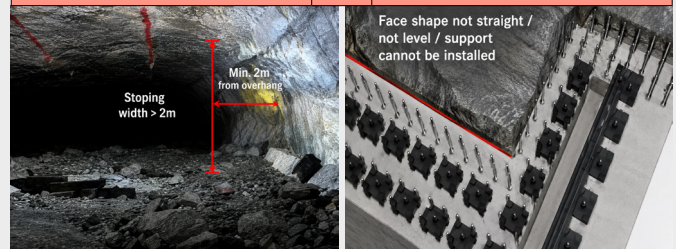
Figure 3: Face shape.

Hazard	Level	Remedial action
Face shape not straight. Full line of support cannot be installed.	T 1	Make safe Drill shorter blast holes at leading portion of face
Overhanging face more than 30cm	T 2	Make safe Use longer top holes to correct overhanging face
Overhanging face combined with High stope width >2.0 m	T 3	Barricade off the affected area. Log in miner's declaration book Notify the M-team
