**Geological Fault Risk
Management at Exxaro
Grooteegeluk Coal Mine**

Reginald Mathivha

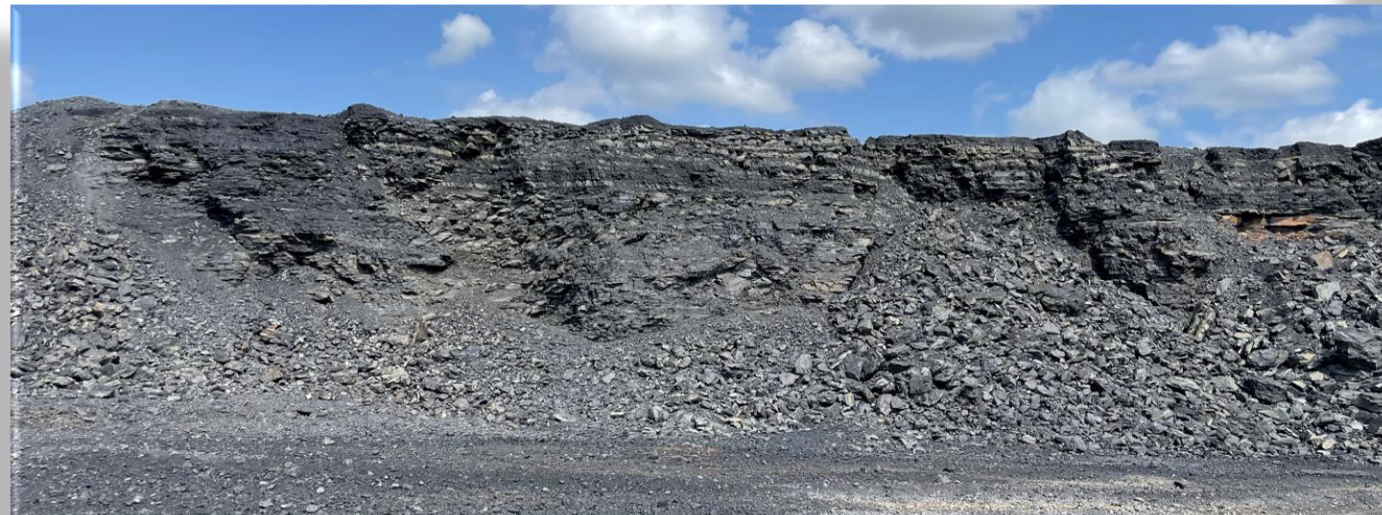
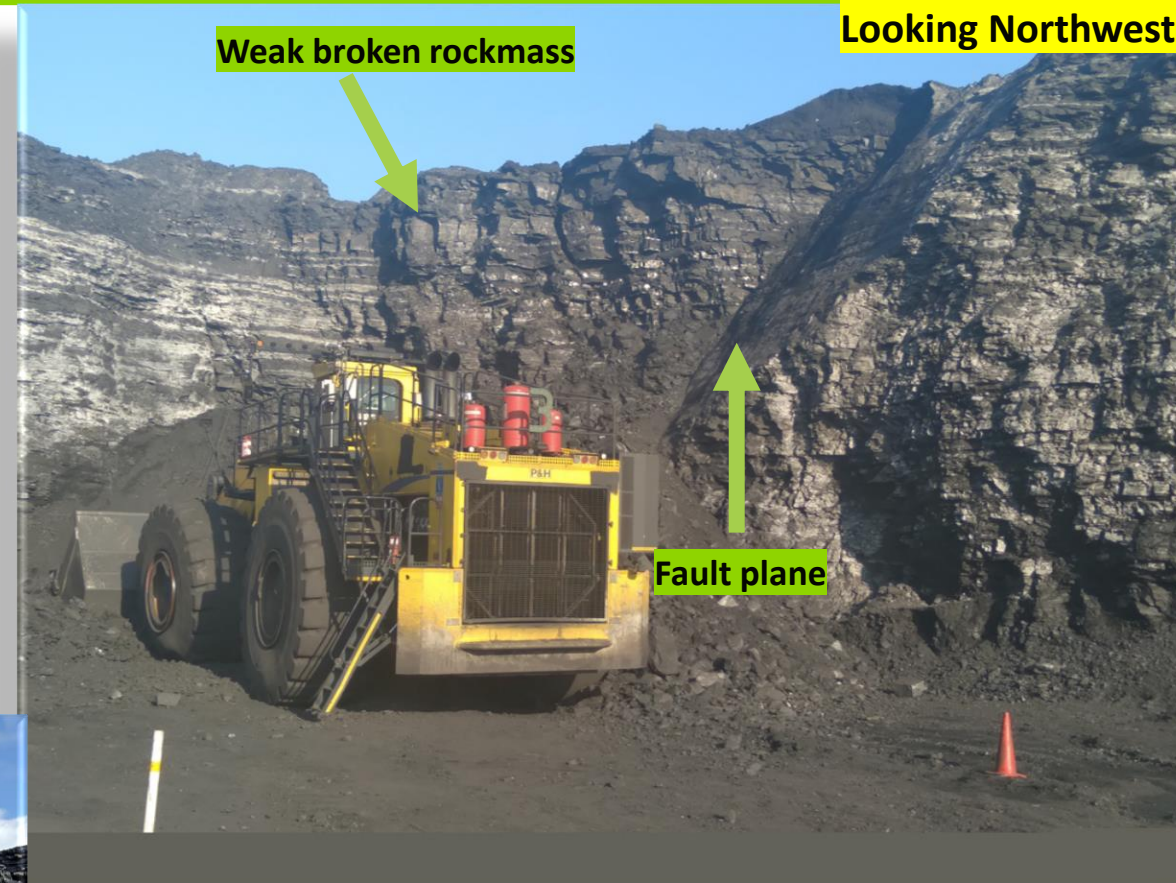
Frozen Blast Block

- A fault is a planar fracture or discontinuity in a volume of rock across which there has been significant displacement owing to rock-mass movements.
- Bench scale fault induced fall of grounds impacting negatively on personnel and equipment
- Ineffective blasting outcomes when faults are not considered in blast designs – Frozen blocks
- Conduits for water groundwater – flooding of active mining areas
- Ore dilution

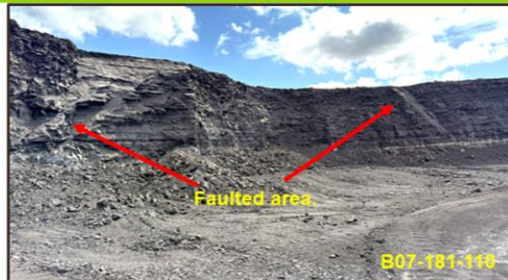
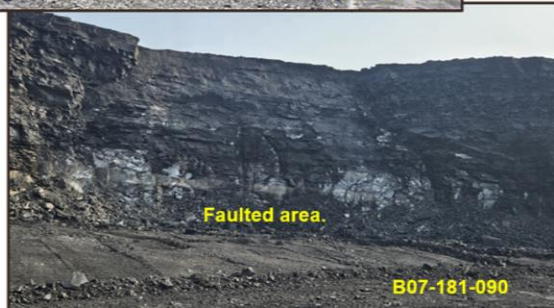
BENCH 7 HIGHWALL – FAULTED GROUND

- Faults intersected on **B07-181-110** and **B07-171-090**.
- Potential Fall of Ground and Slip planes.
- Potential planar failure associated with these faults.
- Not safe for equipment, personnel and infrastructure.

- **Mini Hira** conducted together with **competent persons** for any work taking place within the standoff distance of the Faulted highwall
- **Demarcate** in accordance with the Highwall Demarcation Standard. This includes using a grader lead with safety poles or safety berms, **ensuring a 10m demarcation from the toe of the highwall**.
- **Demarcate 2m away from fault cracks on the crest**
- Communicate with Rock Engineering personnel for any rock related issues.

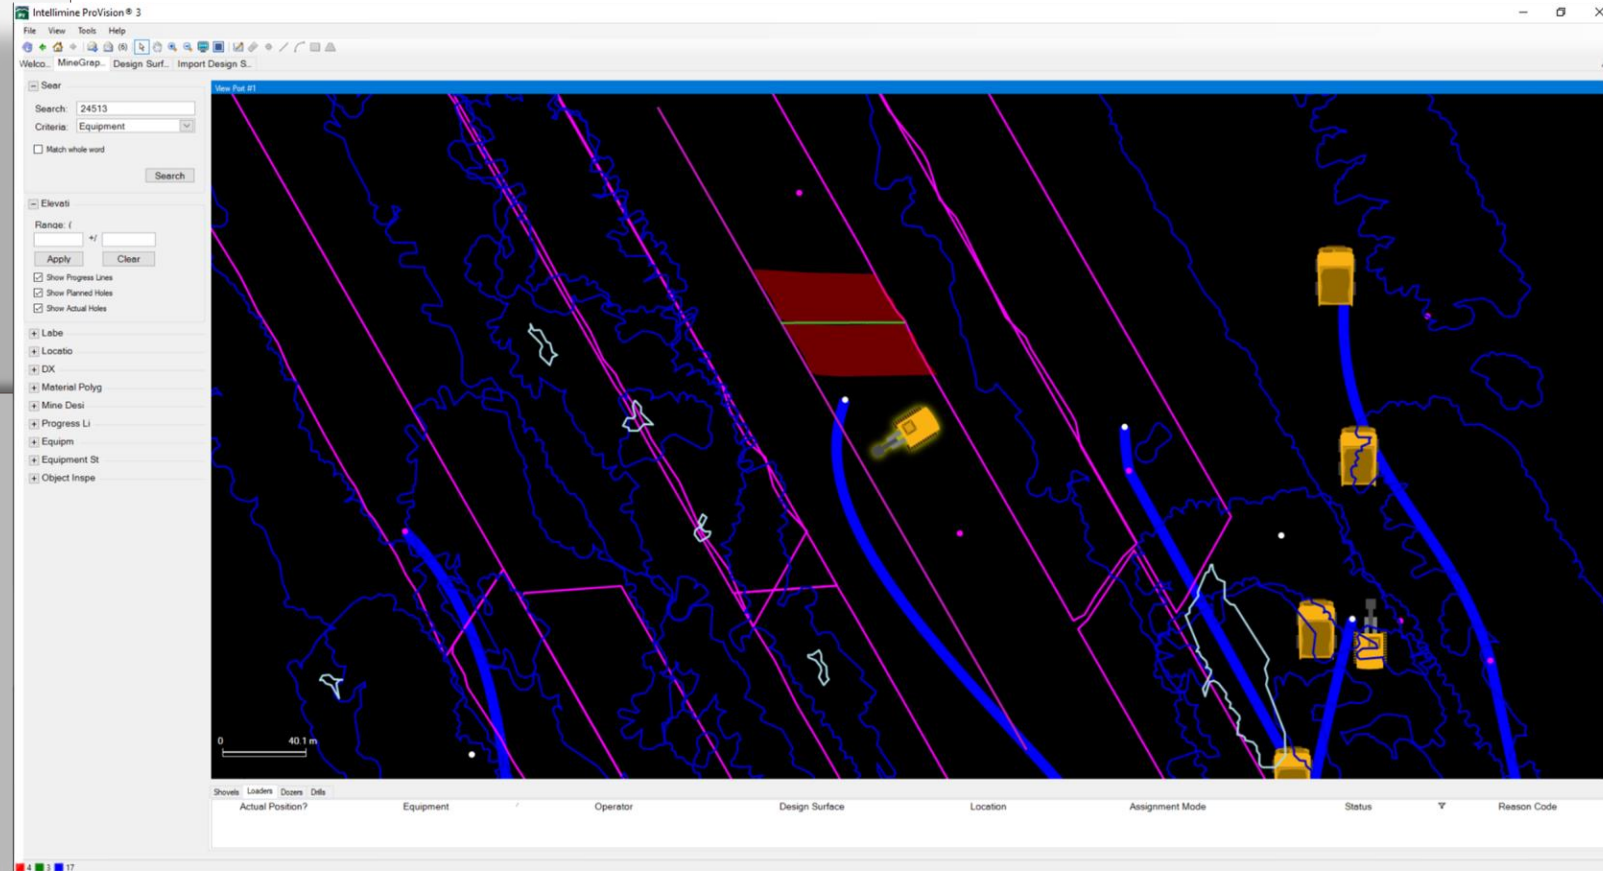
- High precision loading system
- Displays the mining block information i.e., block elevation, material types, faulting & boundaries on the in-cabin screen.
- The proximity to faulted ground will be displayed on the screen, that the operator will use as a guide whilst loading.
- The system itself offers guidance to the operator in real-time.
