SERITI KHUTALA COLLIERY CONVEYOR BELT AUTOMATED TRANSFER POINT FOGGING DUST SUPPRESSION SYSTEM (CBAT) CASE STUDY

Health and Safety Case Study: Application of the MOSH Conveyor Belt Automated Transfer (CBAT) Point Fogging Dust Suppression System

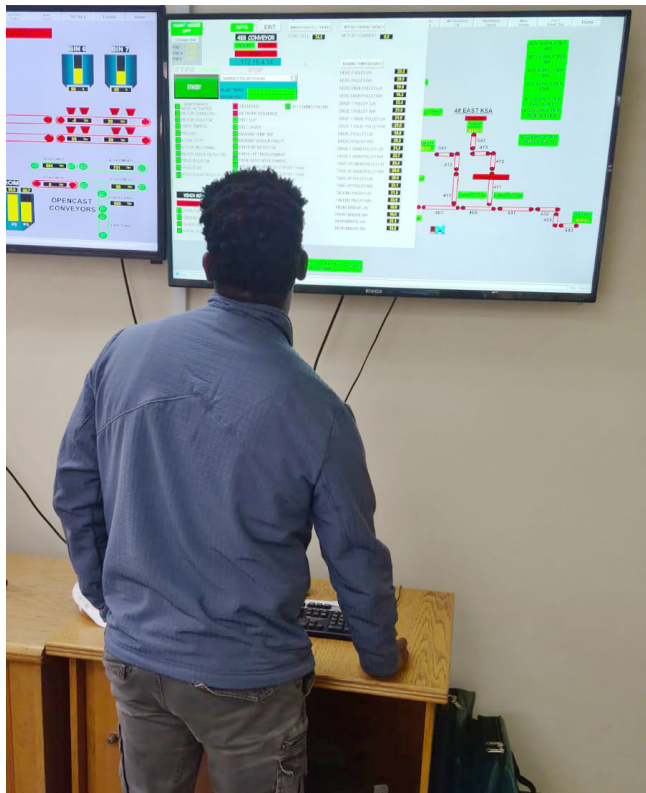
Figure 1: Team viewing the Conveyor Belt Overview System which indicates the operation’s underground conveyor belt system and the location of the CBAT and CRTM System. Source: Seriti Khutala Colliery

To ensure ongoing effectiveness, Continuous Real Time Dust Monitors (CRTM) are installed downstream of each CBAT unit. The CRTM data is transmitted in a live SCADA system, enabling Control Room Operators to track system performance and respond swiftly to elevated dust readings. High- dust events are logged in Isometrix Incident Management System, investigated, and reviewed during the operation’s weekly Assurance meetings with senior management.

Continuous Real Time Dust Monitors (CRTM) are also strategically installed with every CBAT system. These feed into a live SCADA system, enabling Control Room Operators to track CBAT system performance and respond swiftly to elevated dust readings. High-dust events are logged in Isometrix Incident Management System, investigated, and reviewed during the operation’s weekly Assurance meetings with senior management enabling the operation to be more effective in managing the dust risk.

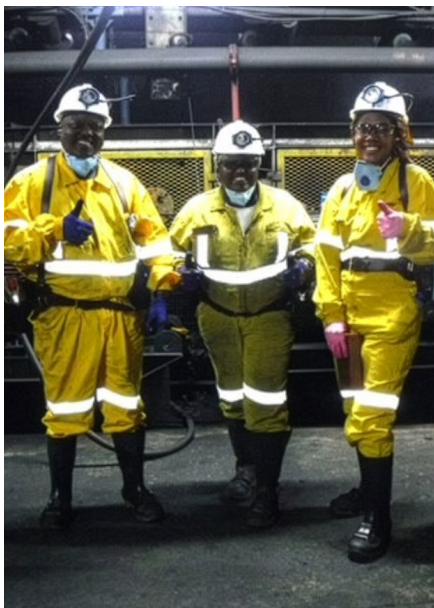
EVENT DESCRIPTION
 it was observed that sprays at the 2e4 transfer point not working . it was also presence of high dust generated in the vicinity of the chute.

INVESTIGATION CLOSURE
Root cause
 Blocked sprays on the dust suppression system due to scale in the supply water.
Immediate cause

Figure 2: An example of a High Dust Incident report which has been logged in Isometrix. Source: Seriti Khutala Colliery

ACTIONS					
Action description	Department responsible	Due date	Responsible person	Status	LFI
Clean or replace blocked sprays to ensure effective dust suppression system operation.	Seriti Resources -> Seriti Power -> Khutala -> Underground 2 Seam	2024-04-17		Completed	No
